Electrical Thermography Report

Inspected Items:
Customer Designated Electrical Equipment
Street Address
Anytown, USA

**ALPINE BUILDING
INSPECTION INC.**
303-642-2300
www.alpineinspection.com

Inspection Date: Tuesday, March 22, 2010
Camera Model: FLIR EX 320
Report ID: R100322A

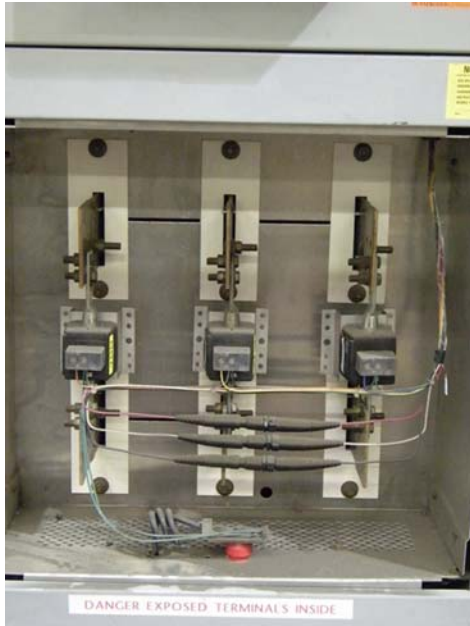
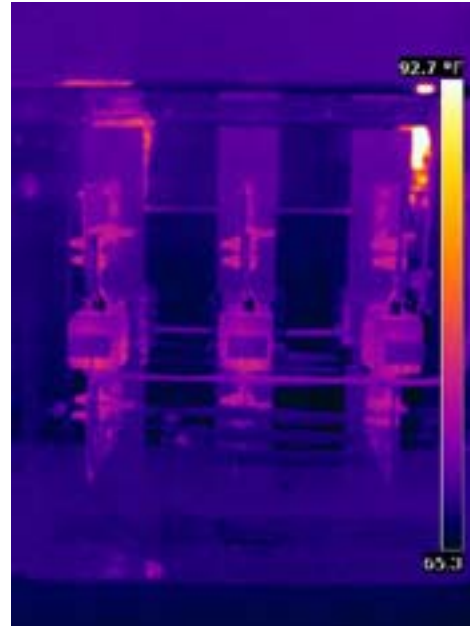
Building:	Main Building			Ambient Temp: 70F
Location:	Production Floor			Temp Spot 1:
Equipment:	Service Entrance Connections			Temp Spot 2:
Equipment ID:				Max Temp: 77.2F
Phase:	L1	L2	L3	Temp Rise Over Ambient: 7.2F
Load(A):				Status: Ordinary
Rated Load:				Action Level: None

Comments / Recommendations
 Apparent hot spot at upper right is only a reflection.

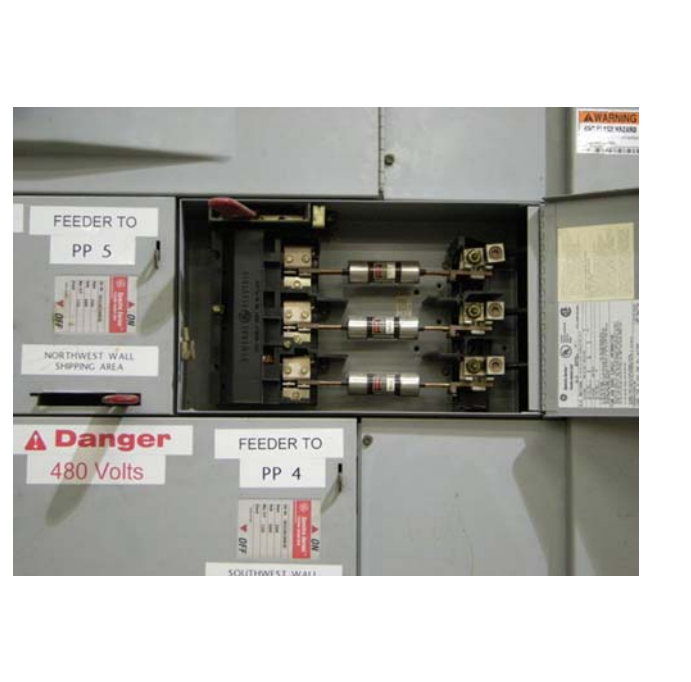
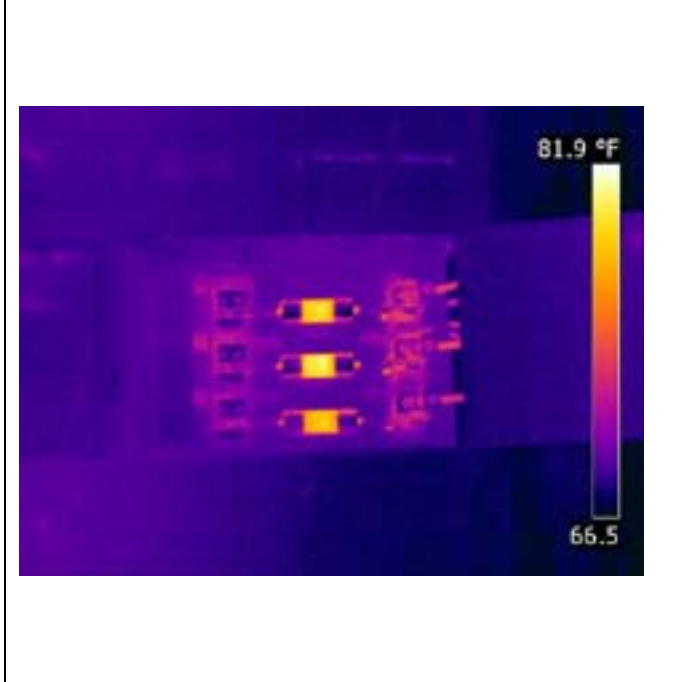
Building:	Main Building			Ambient Temp: 70F
Location:	Production Floor			Temp Spot 1:
Equipment:	PP6 Disconnect			Temp Spot 2:
Equipment ID:				Max Temp: 80.9F
Phase:	L1	L2	L3	Temp Rise Over Ambient: 10.9F
Load(A):				Status: Ordinary
Rated Load:				Action Level: None

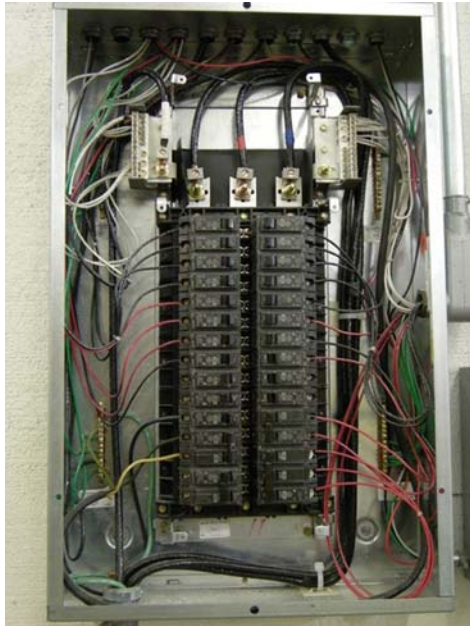
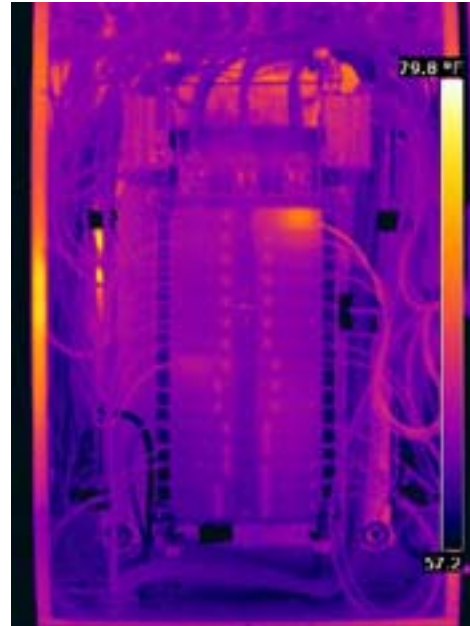
Equipment: New East Wall 120 Panel

Max Temp: 77.5F

Temp Rise Over Ambient: 7.5F

Status: Ordinary

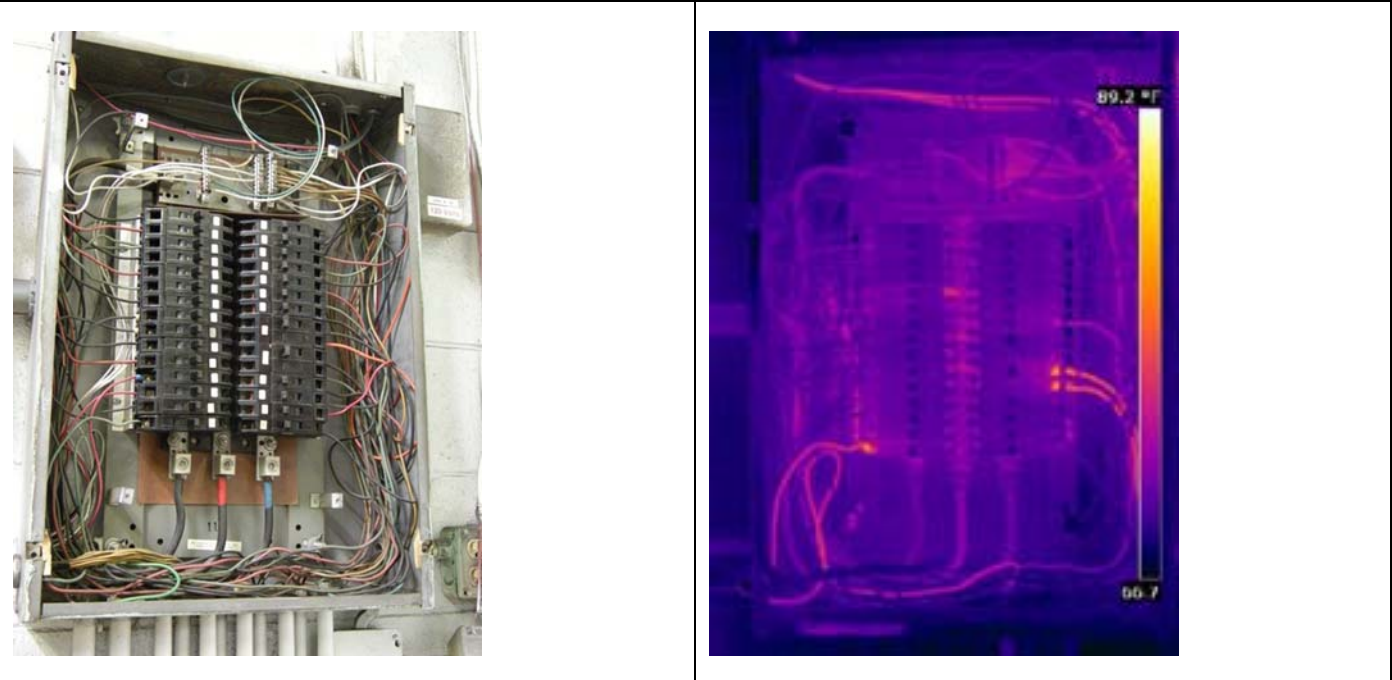
Building: Main Building				Ambient Temp: 70F
Location: Production Floor				Temp Spot 1:
Equipment: West Wall LP4				Temp Spot 2:
Equipment ID:				Max Temp: 83.8F
Phase:	L1	L2	L3	Temp Rise Over Ambient: 13.8F
Load(A):				Status: Alert
Rated Load:				Action Level: Check

Check center bus connection on left fifth breaker down for tightness.

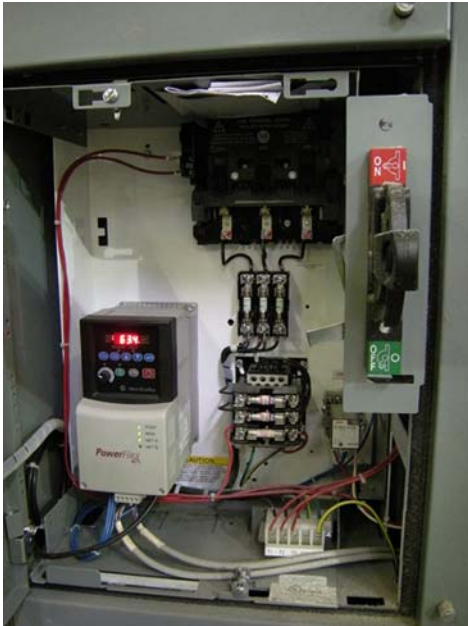
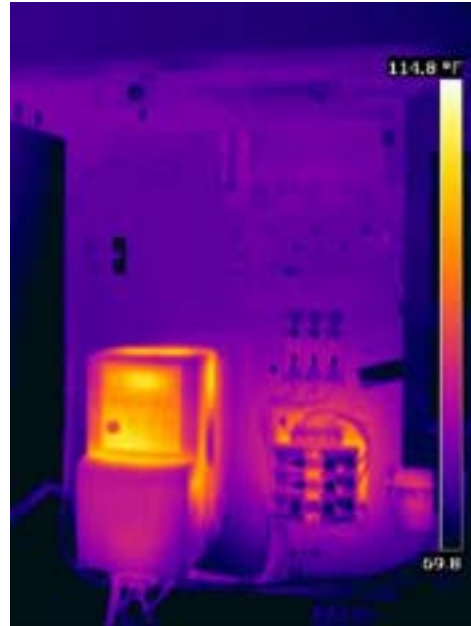
Building: Main Building				Ambient Temp: 70F
Location: East Wall MCC				Temp Spot 1:
Equipment: Out Feed Motor				Temp Spot 2:
Equipment ID:				Max Temp: 109.2
Phase:	L1	L2	L3	Temp Rise Over Ambient: 39.2F
Load(A):				Status: Ordinary
Rated Load:				Action Level: None
